REPORT DOCUMENTATION PAGE		READ INSTRUCTIONS BEFORE COMPLETING FORM
1. REPORT NUMBER	2. GOVT ACCESSION NO.	3. RECIPIENT'S CATALOG NUMBER
AD A092220		
4. TITLE (and Subtitle) Phase I Inspection Report Lake Suzanne Hudson River Basin, Rockland County, New York Inventory No. 760		5. TYPE OF REPORT & PERIOD COVERED Phase I Inspection Report National Dam Safety Program

PHASE I INSPECTION REPORT  
NATIONAL DAM SAFETY PROGRAM  
LAKE SUZANNE DAM  
I.D. NO. N.Y. 760  
D.E.C. NO. 196D-4179  
HUDSON RIVER BASIN  
ROCKLAND COUNTY, NEW YORK

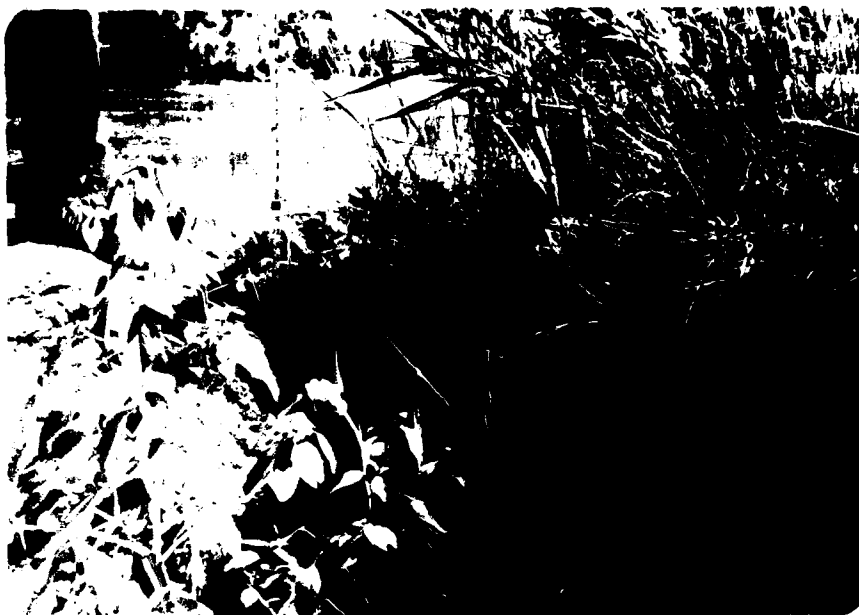
The left abutment and the downstream toe of the embankment could not be accurately located because of flat topography, heavy vegetation and ground cover. However, from available information, the length of the embankment is estimated to be about 50 feet; the upstream and downstream slopes are about 1 vertical and 4 horizontal and 1 vertical and 5 horizontal, respectively. The embankment appears generally to be in good condition except in the vicinity of the spillway-embankment contact, where the embankment fill downstream of the left spillway training wall has been eroded apparently as a result of overtopping. A portion of the eroded area was backfilled with a mass concrete blanket immediately downstream of the training wall leaving the remaining portion unrepaired. In addition, subsequent overtopping or runoff has eroded a 3 foot wide, 3 foot deep gully between the embankment and the concrete blanket (See Photograph 6).

6. VIEW AT CONTACT BETWEEN DOWNSTREAM FACE OF LEFT SPILLWAY TRAINING WALL AND THE EMBANKMENT. NOTE EROSION OF EMBANKMENT FILL.

1. Backfill the eroded area of the embankment downstream of the left spillway training wall (spillway-embankment contact).
2. The reservoir drain should be returned to operating condition.
